Characterization of Composites for Use in the Ball-Joints of the Maeslant Storm Surge Barrier

W. Van Paepegem,¹ J. Degrieck,¹ P. Samyn,¹ P. De Baets,¹ L. Van Schepdael,² J.S. Leendertz³

In 2004, the rehabilitation works of the Maeslant storm surge barrier in the Netherlands were finished. The two gates of the barrier are attached to a pivotal point on both banks. The pivotal points are designed as two large ball-joints (10 m diameter) that must allow for both horizontal and vertical movements of the gates. Five hundred individual composite material discs provide a low friction sliding contact with the ball. Two designs for the composite material discs are discussed in this article: (i) a polyester/polyester disc with a Teflon coating and (ii) an UHMWPE (ultra-high molecular weight polyethylene) disc with a reinforcing carbon/epoxy ring. The test methods for characterization of the composite materials are presented. It is shown that internationally standardized test methods do not provide all necessary information and that additional measurements have to be made. Based on the results of these tests, the best design has been integrated in the storm surge barrier. *POLYM. COMPOS.*,

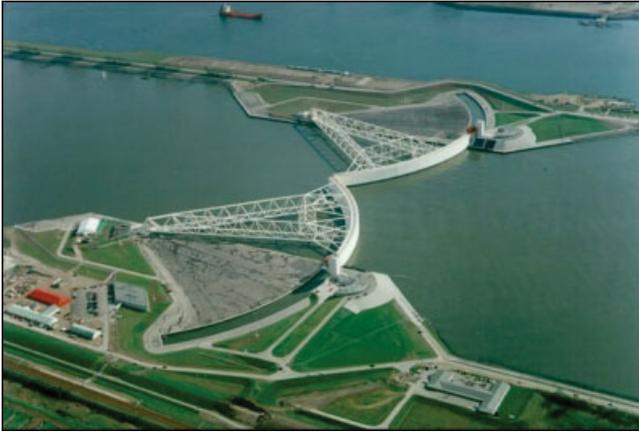
FIG. 1. View on the Maeslant storm surge barrier [1]. [Color figure can be viewed in the online issue, which is available at www.interscience.wiley.com.]

This Maeslant storm surge barrier consists of two hollow semicircular gates attached by means of steel arms to a pivotal point on both banks, as illustrated in Fig. 1. In the event of a storm tide, the “parking” docks are filled with water, so that the hollow gates start to float and can be turned into the New Waterway. Once the gates meet, the cavities are filled with water and the gates sink to the bottom, thus sealing off the 360 m wide opening.

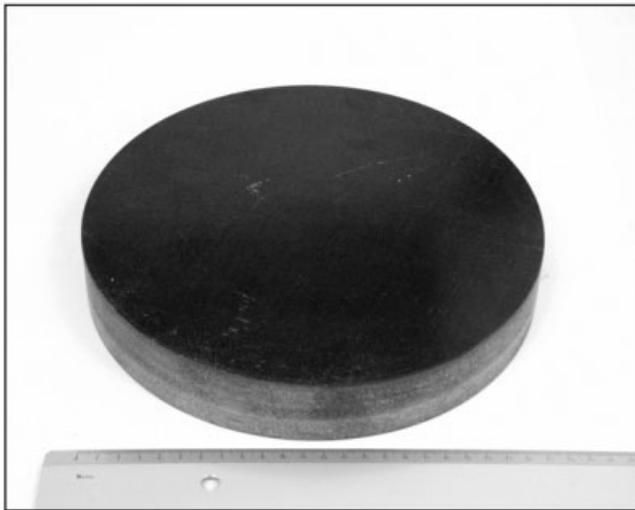
FIG. 3. View of the polyester/polyester disc with Teflon coating.

Figure 3 shows the polyester/polyester disc with Teflon coating. The composite sliding pads consist of woven polyester fabrics (90°) impregnated with a thermosetting polyester resin. For use in the ball-joints, the elastic properties and the behavior beyond the elastic region had to be characterized. In-service deformations of 10% and more could be expected.
